Melbourne Testing Services Pty Ltd

REPORT NO: MT-11/498

TESTING OF A TEMPORARY FENCE SYSTEM

CLIENT: AAC TEMP FENCE
24 RAMAGE ROAD
BUNINYONG VIC 3357

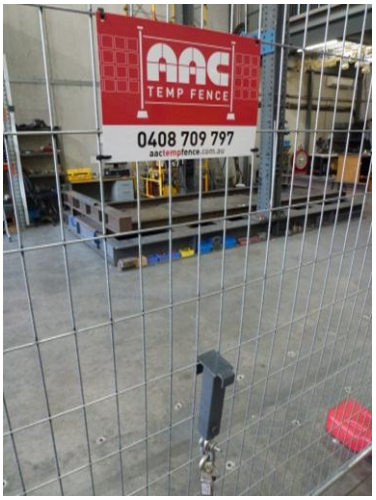
FIG.4
INFILL DOWNWARD TEST

To test that the infill mesh had sufficient stiffness to resist an attempt to climb the fence, a downward load of 100kg was applied at one of the rectangular shaped openings (see Fig.4). This load was maintained for 60 seconds at which point the downward deflection of the infill material was recorded.

Infill downward load test resulted in a deflection of **5mm**, less than the specified permissible maximum of 35mm.
